Test Report

No.: 64.190.24.0357.01-00

Applicant: ARTFOX ELECTRONICS Co.,LIMITED
Address: Building 1, Wanyang, Huanglong, Beijiao, Shunde, Foshan, Guangdong, 528306, China
Sample Submission: The sample was submitted by applicant and identified.
Product Name: Easy stage
Order No.: /
Identification/Style No.: 2.44 x 2.44m
Manufacturer: ARTFOX ELECTRONICS Co.,LIMITED
Country of Origin: /
Buyer: /
Export to: /
Receipt Date of Sample: 2024-04-24
Date of Testing: From 2024-04-24 to 2024-04-24
Test Result: Refer to the data listed in following pages

1. Loading test according to client's requirements

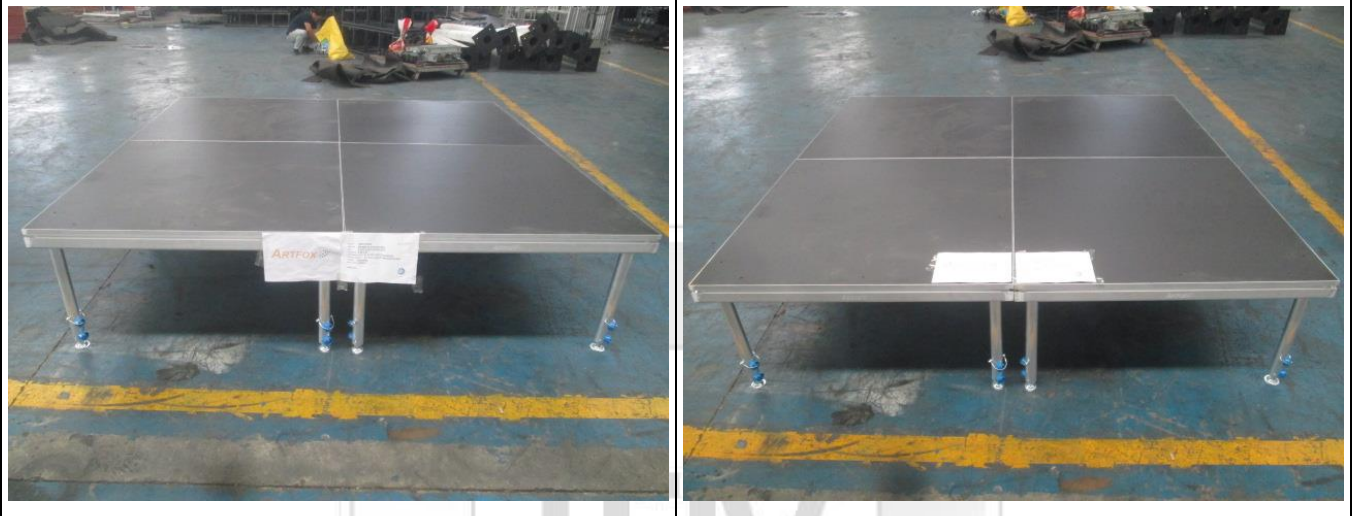
Sample photo(s)

1	Product Description	Simple stage	
2	Dimensions	Overall Dimension(m):	L2.44 x W2.44 x H0.6
		Unit deck dimension(m):	L1.22 x W1.22 x H0.6

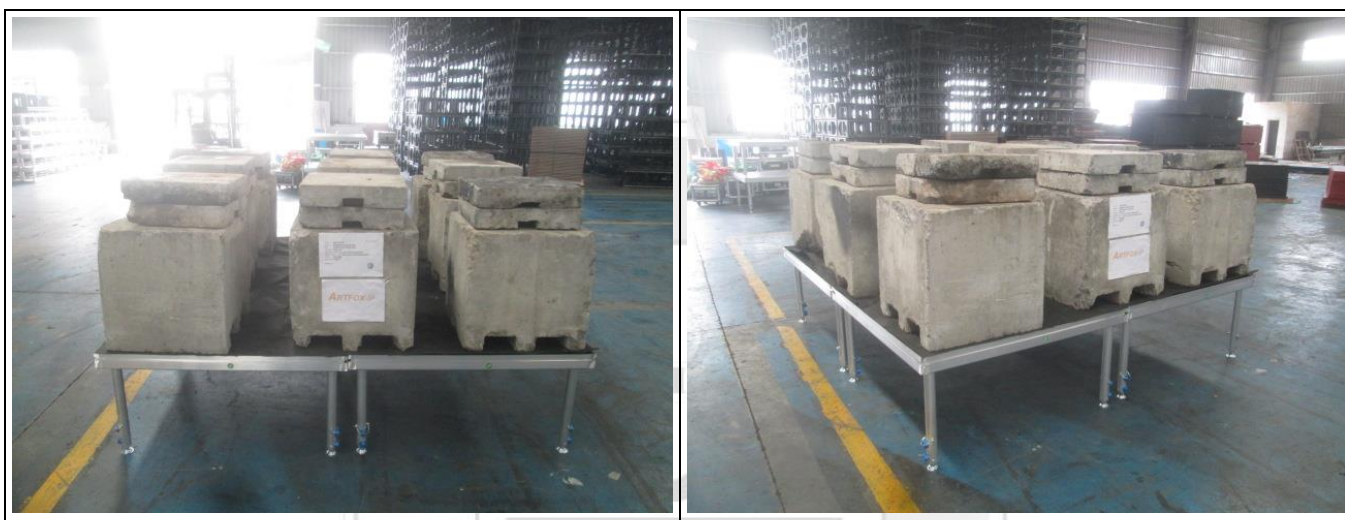
TESTING PHOTO

Test item	Requirement ~ Test	Measuring result ~ Remark	Verdict
Loading test	After installation, a total load of 4806kg is uniformly applied to the aluminium stage. Maintain the load for 5 minutes. Visually evaluated the deformation and stability of the sample during and after the test.	No visible damage and deformation were found during and after the test.	/
